TOWNSHIP OF LONG HILL SANITARY UTILITY SYSTEM ASSET EVALUATION & CAPITAL IMPROVEMENT PLAN

January 2017

Prepared By:
Remington & Vernick Engineers
232 Kings Highway
Haddonfield, NJ 08033
856-795-9595

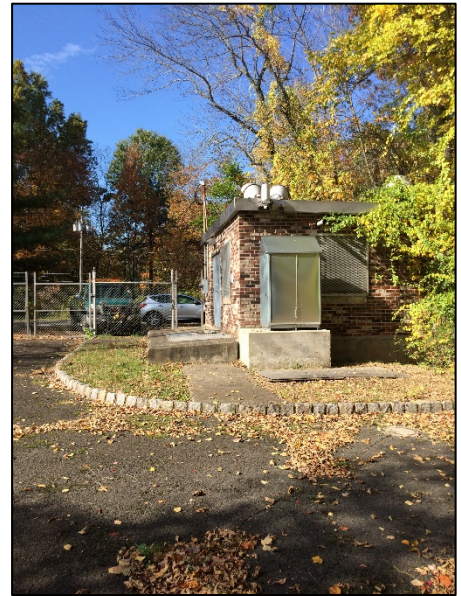
Photo #18 – Rear of pump station; diesel tank on elevated pad

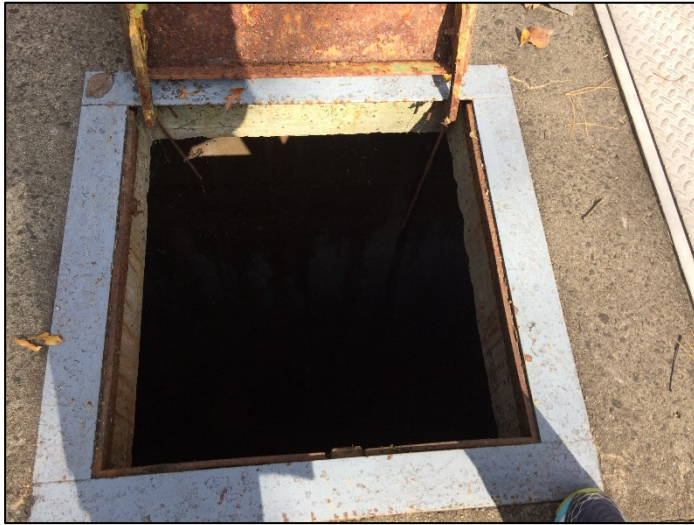
Photo #21 – Wet well hatch

The hatch to the wet well is showing signs of deterioration and should be scheduled for replacement. In addition, stairs and safety grating should be installed in the wet well.

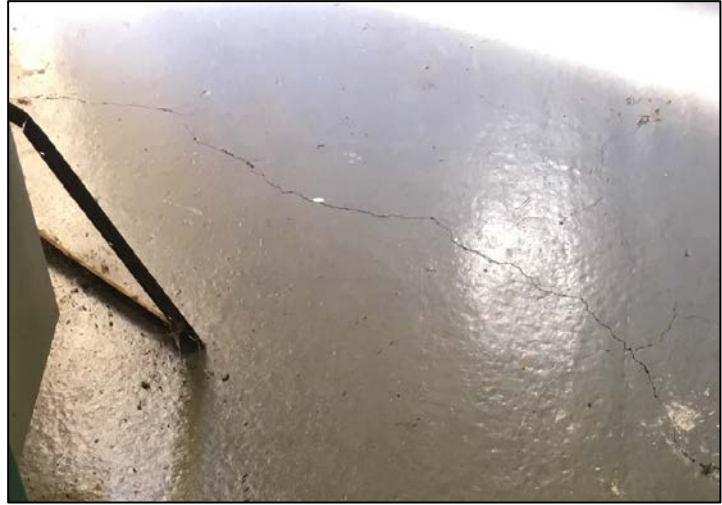
Photo #30 –Minor floor surface cracking at generator. Fill and monitor.

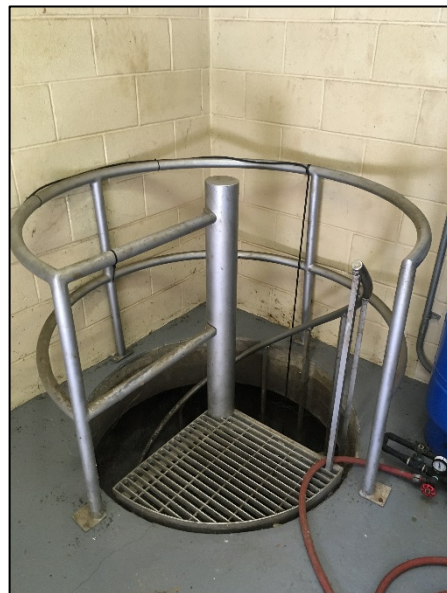
Photo #32 –Spiral stairs to lower level

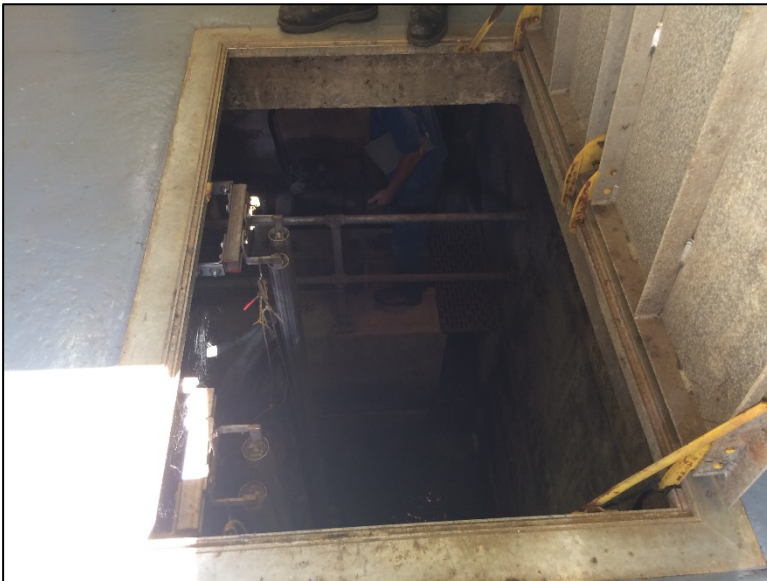
Photo #33 –View of wet well area requiring safety grating

It was also noted that the wet well access/walkway was deficient of safety grating. The installation of safety grating has been incorporated into the 20-Year Capital Improvement Plan for worker safety considerations.

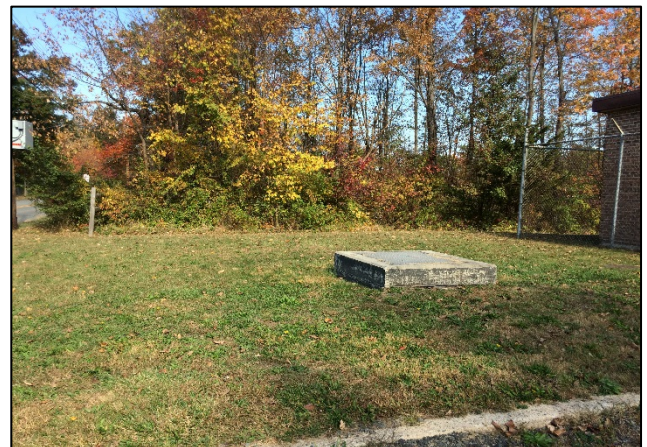
Photo #37 – Potable Water Well

Water supply to the building is via an onsite potable well. It has been stated that the well floods. Accordingly, the well should be raised above the flood elevation. In addition, the well needs a new pump and it was indeterminate if a backflow preventer. It is recommended that the well piping and system connections be reviewed to confirm the presence of a backflow preventer. Should one not exist, the backflow valve will be incorporated into the plan.

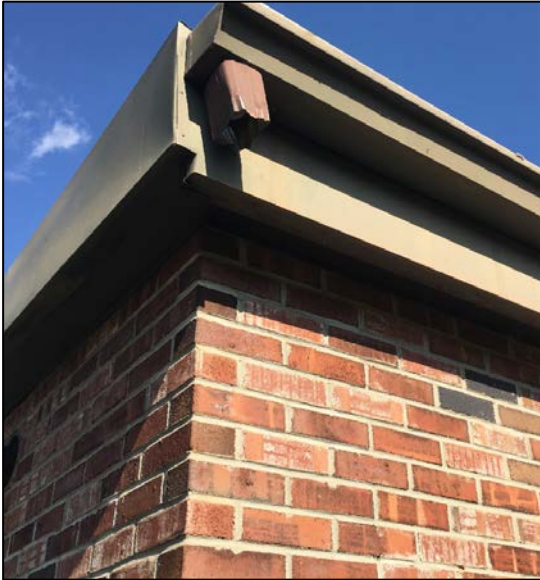
Photo #53 – Missing downspouts

The pump station is a duplex submersible station and consists of a below grade wet well. The structure is a brick and CMU bearing wall structure on a concrete foundation with a lightweight concrete block roof. Overall the structure appears to be in good shape. However, metal edge flashing is damaged in some areas and downspouts are missing. It also appears that previously the downspouts discharged below grade.

The metal flashing should be replaced as well as the downspouts in order to protect the structure from water infiltration / damage. The discharge of the downspouts should be modified to allow discharge at ground level with concrete splash blocks. In addition, the roof appears to be original to the building and should be included for replacement during the planning period.

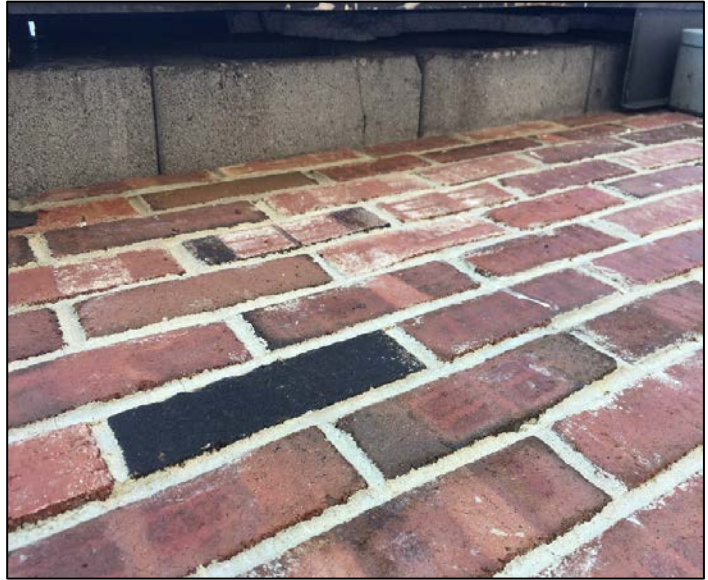
Photo #54 – View looking up at roof – missing flashing

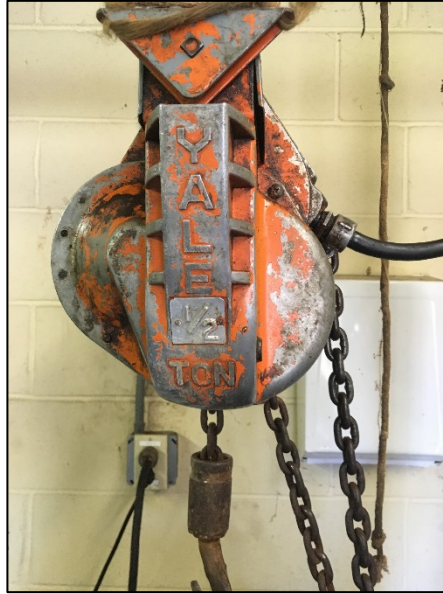
Photo #55 & #56 – Existing hoist – to be replaced

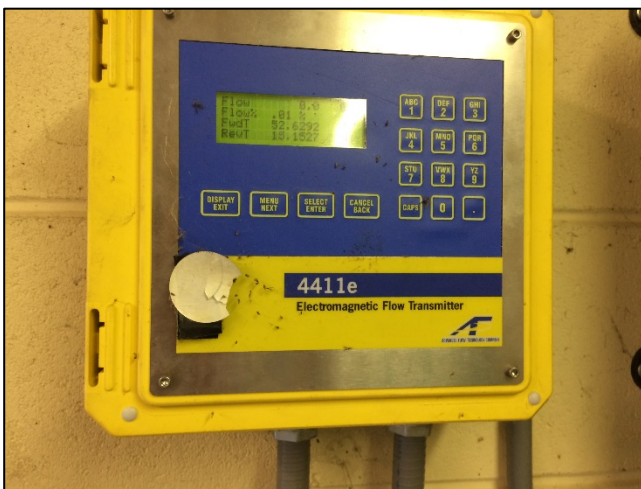
Photo #59 – Flow meter – to be replaced

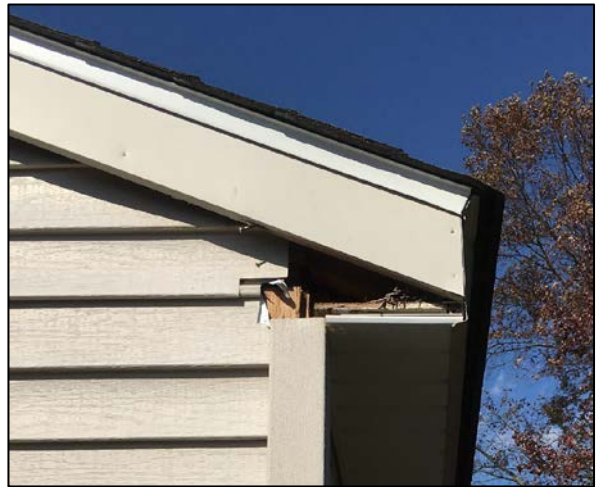
Photo #67 – Emergency Generator / Control Building Photo #68 – Soffit requiring replacement

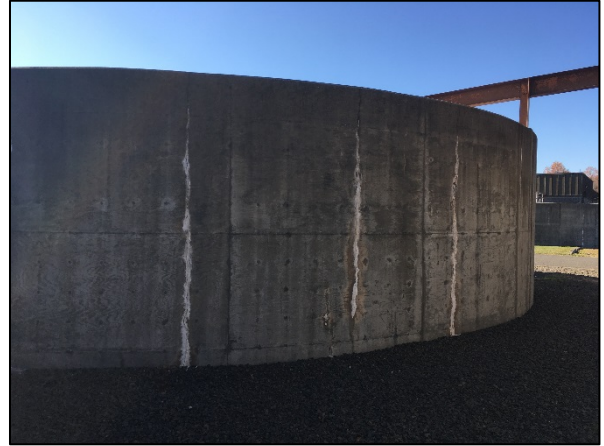
Photo # 95 & 96 – Cracks, seepage and mineral buildup on oxidation ditch structures

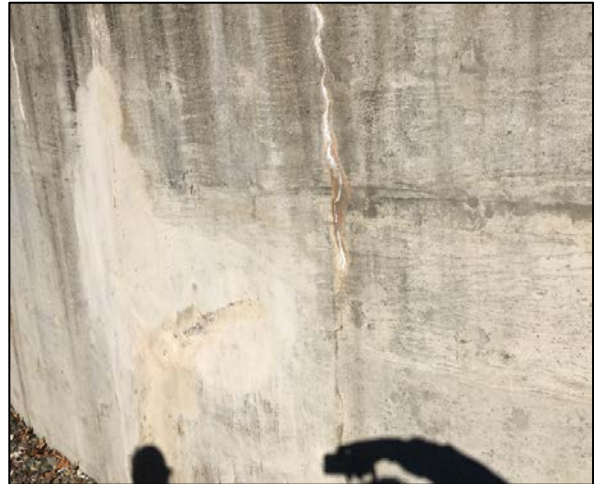
Photo #99– Repaired tank structure with adjacent vertical crack

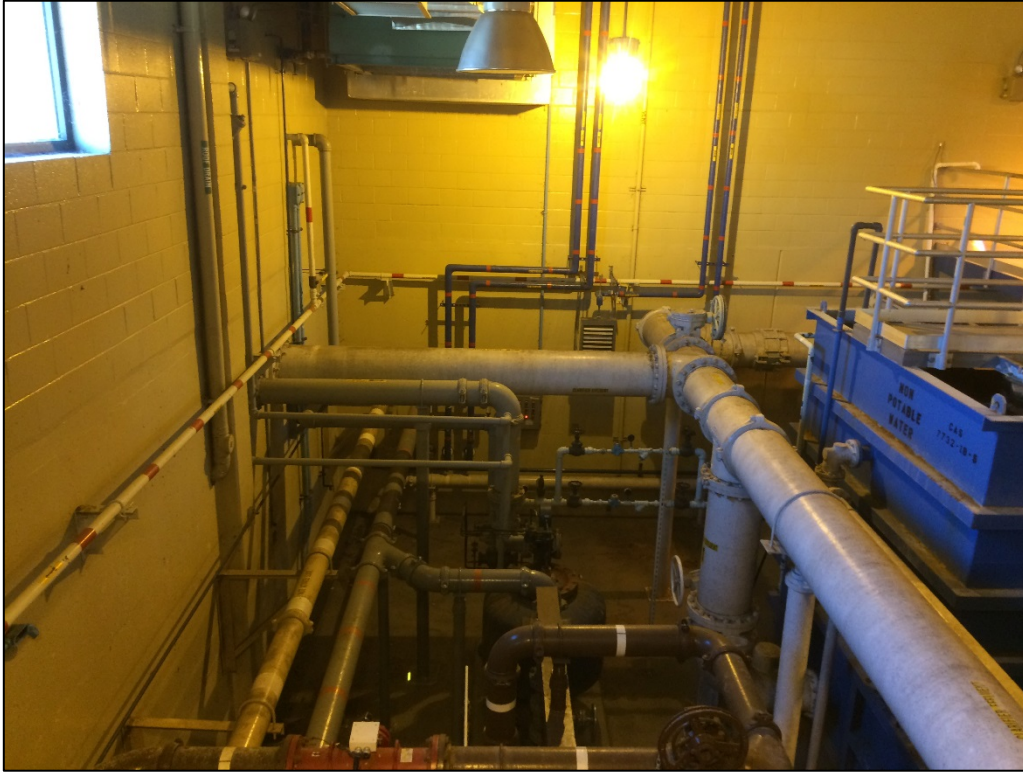
Photo #102 – HVAC and lights are inaccessible. Install catwalk for maintenance and repair

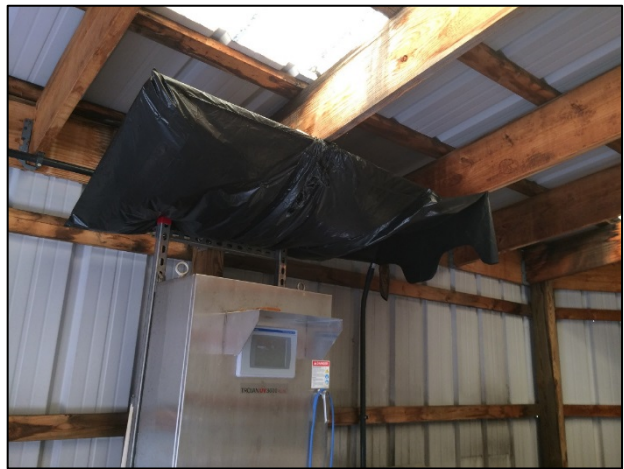
Photo #108 – Leaking roof over UV Controls

UV control panel and a plastic tarp is being used to protect the controls from water damage.

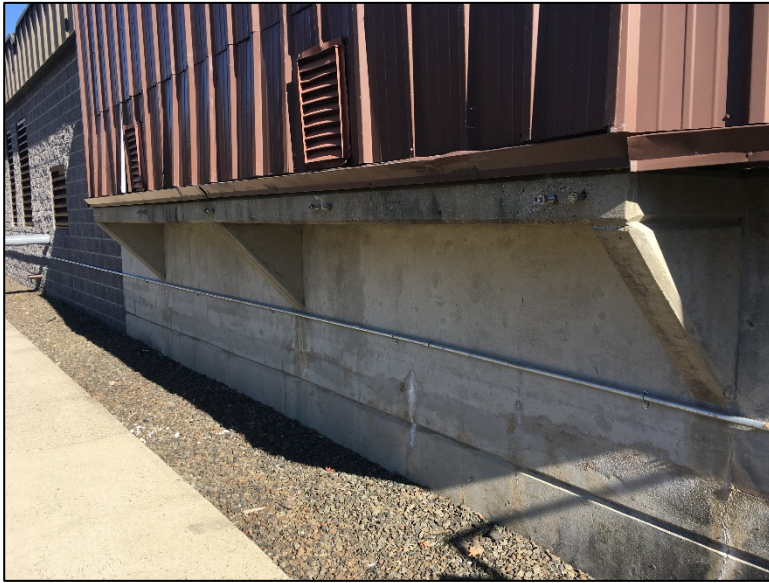
Photo #109 – Cantilevered UV Building – requiring additional support

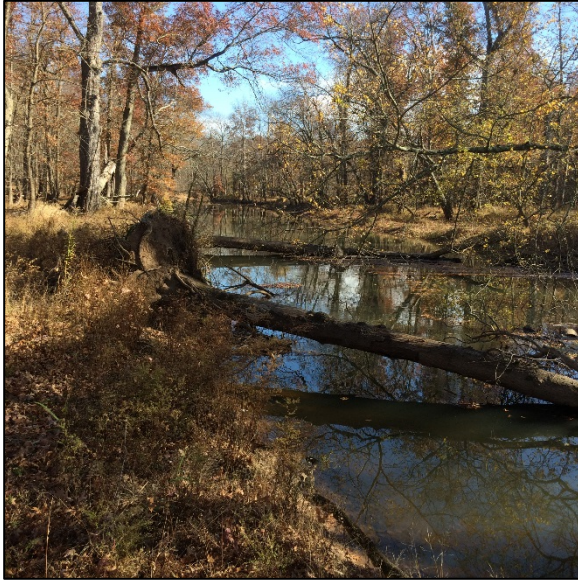
Photo #110 – Tree/Debris near outfall

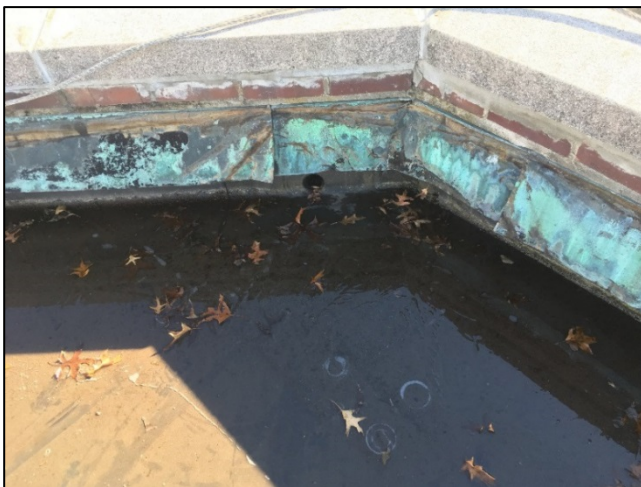
Photo #117 & #118 – Sludge Building / Tank – ponding water on roof
